EMERGENCY RESPONSE REPORT

SHARP PERFORMANCE CHEMICAL ACID RELEASE

5921 PLAINVIEW

16 April 2009

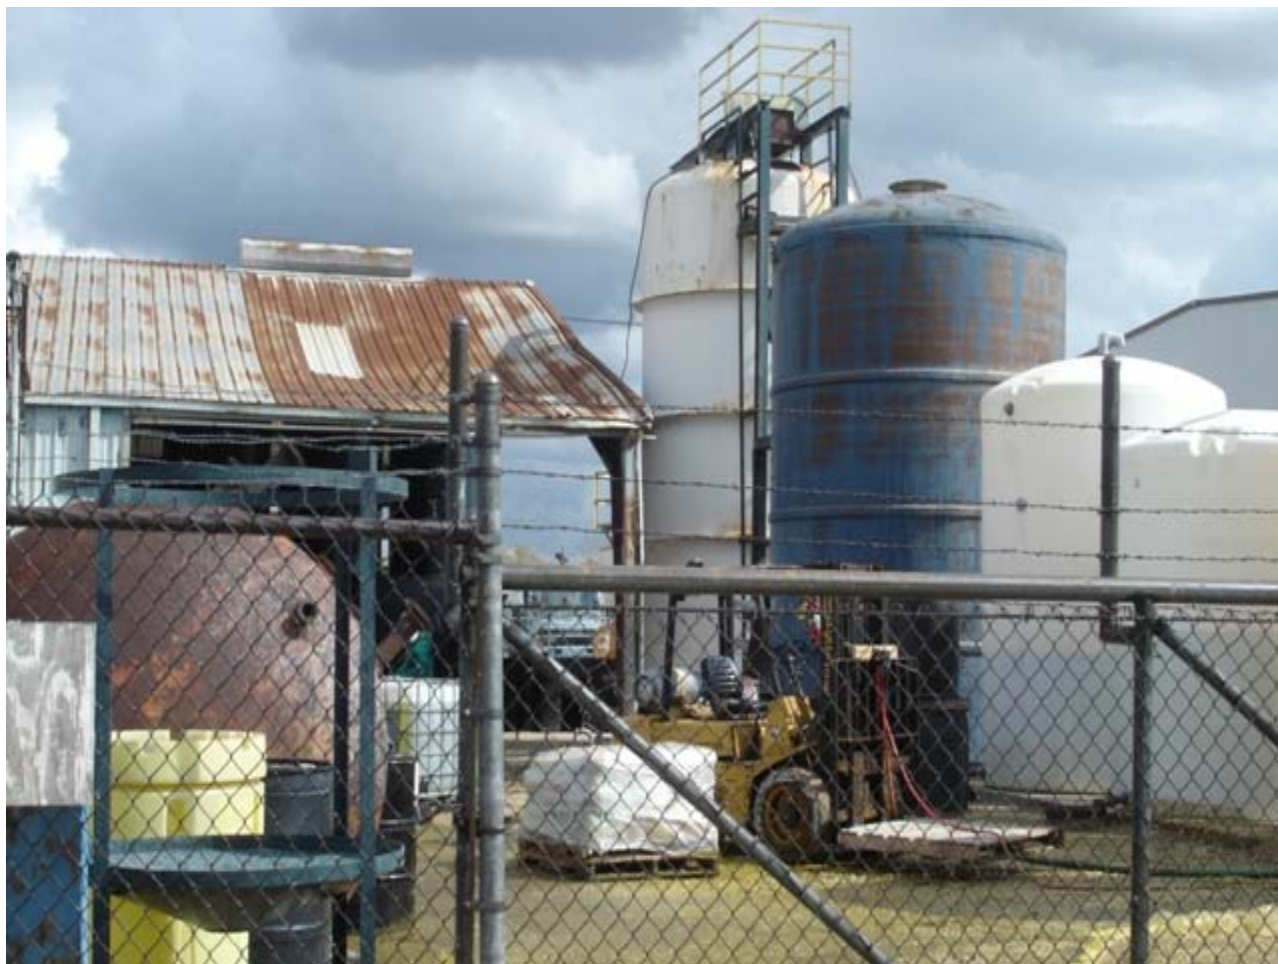
Photo Name: 20090201_1258A.JPG

HFD conducted a Level B entry into the facility to determine the source of the release and potential remediation options. At that time it was determined that a faulty gasket/piping assembly was the source of the leak. HFD placed a small tote underneath the gasket/piping assembly in attempts to prevent any further release of the material. HFD also determined that offloading the tank would be required to minimize the potential for another release. HFD cut a

Caption: View of 10,000 gallong tank, source of spill and view of release on ground

hole in the AST and began transferring the product from the AST and the small tote into additional totes provided by Sharp Performance Chemical. Based on the amount of product transferred from the AST, it is believed that approximately 2,500 gallons of product was released. Upon final completion of the transfer of material, no new product was being released and HFD departed the site.

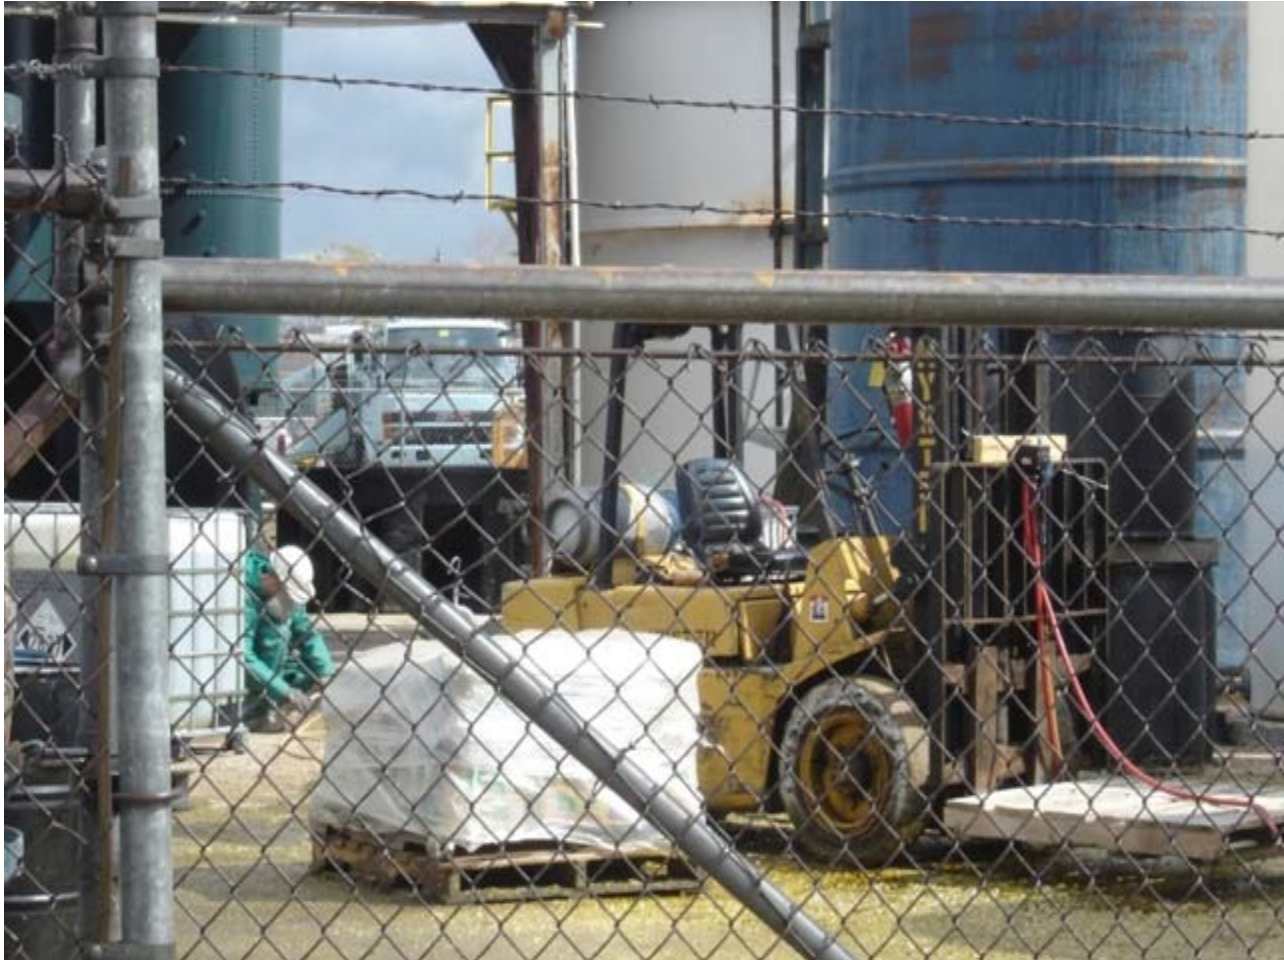
Caption: PRP employee wearing respirator applying pot ash inside facility

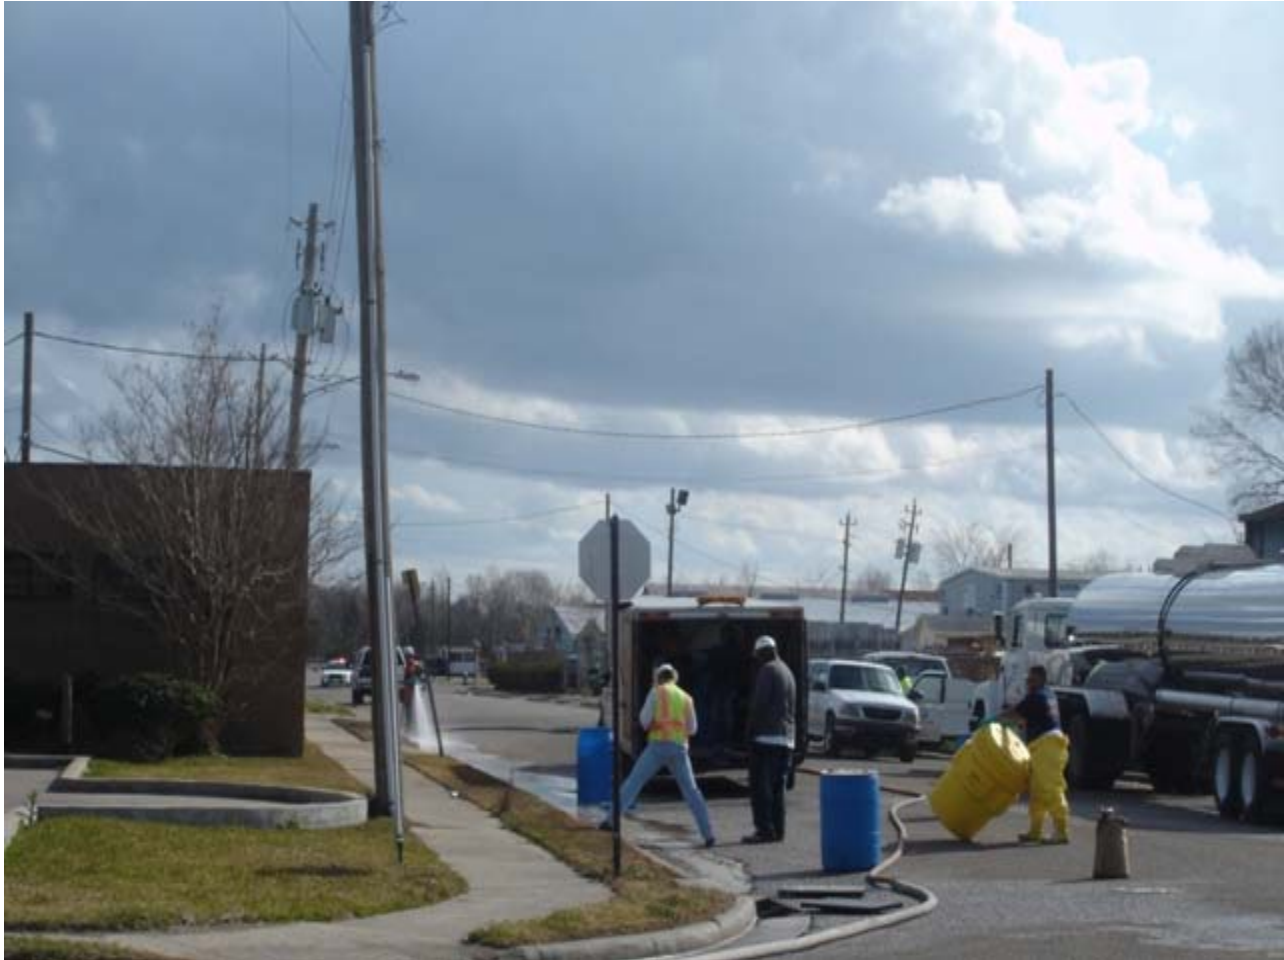
Caption: START contractor collecting pH of liquid in gutter.
